GILA RIVER BASIN NEW RIVER AND PHOENIX CITY STREAMS, ARIZONA MARICOPA COUNTY, ARIZONA

CAVE BUTTES DAM FOUNDATION REPORT

U.S. ARMY, CORPS OF ENGINEERS

AUGUST 1983

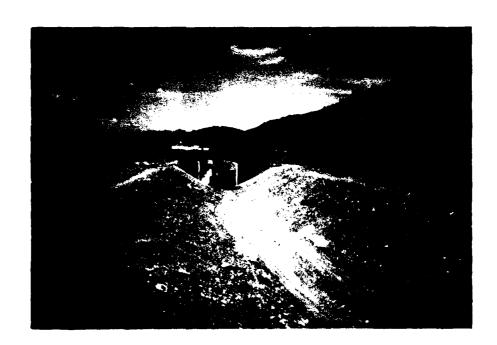
Photo 39 Outlet Works. Portion of concrete backfill near Sta. 50+00 to restore proposed foundation grade.

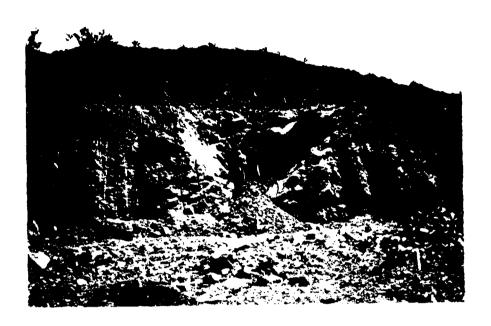
Photo 53 Spillway crest. Left (east) wall after cleaning to remove loose rock; overbreak is at notch for vertical extension of sill.

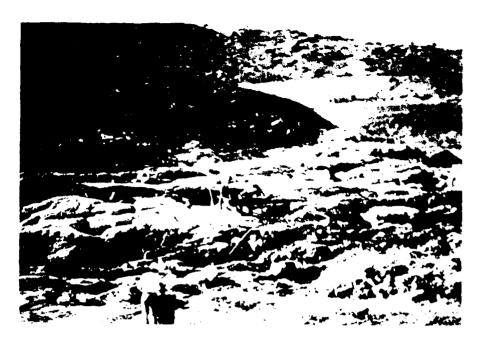
Photo 59 Right (west) abutment. View upstream of foundation treatment between elevations 1,540 to 1,550.

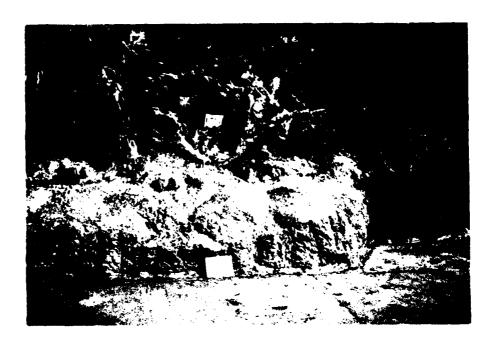
Photo 78 Left abutment, foundation treatment. Elevation 1,565 to 1,570; downstream edge of zone I foundation in near right edge of photo.

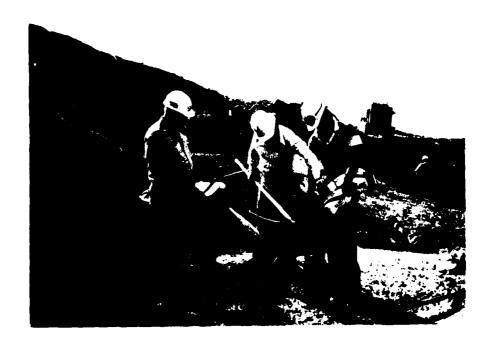
Photo 79 Left abutment between elevation 1,550 to 1,555. Foreman and crew mixing mortar and pea gravel concrete from dry pre-mixed bags for use as slurry grout to fill holes and deep fractures.

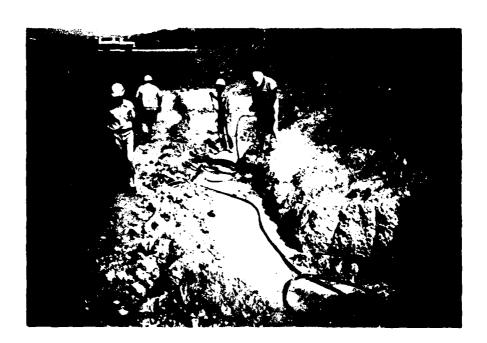
Photo 81 Left abutment. Dental concrete above outlet at elevation 1,565. View is upstream at zone I - zone II contact.
